Navajo Abandoned Uranium Mine

Site Screen Report

Ramco No. 22 AUM Site

Navajo AUM Western Region

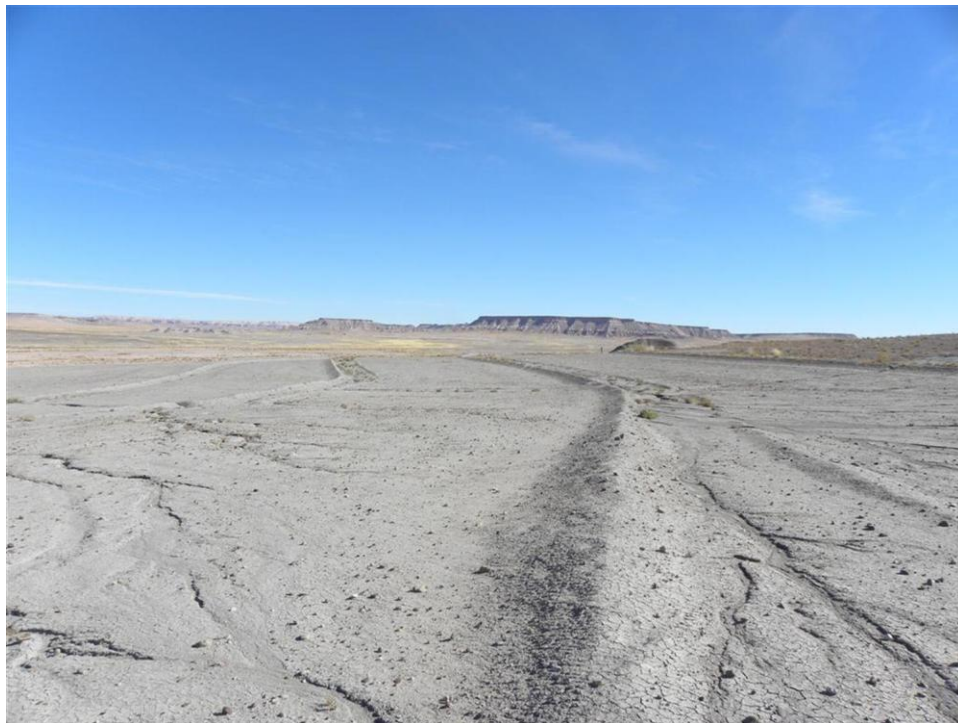
Photo 2. Ramco No. 22 mine site, berm area

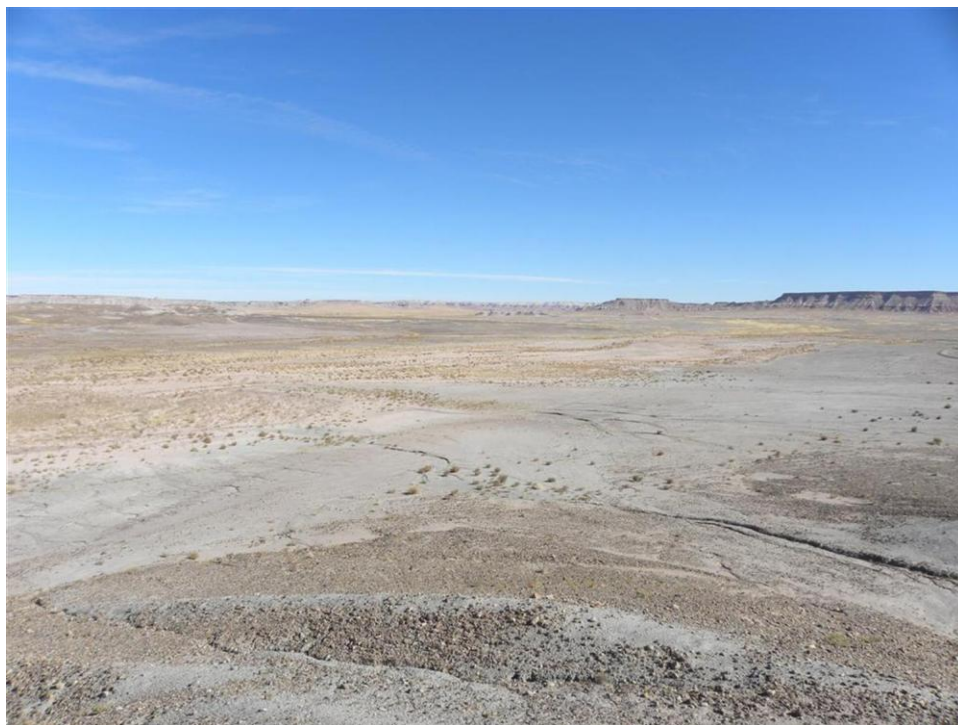
Photo 4. Ramco No. 22 mine site, berm area

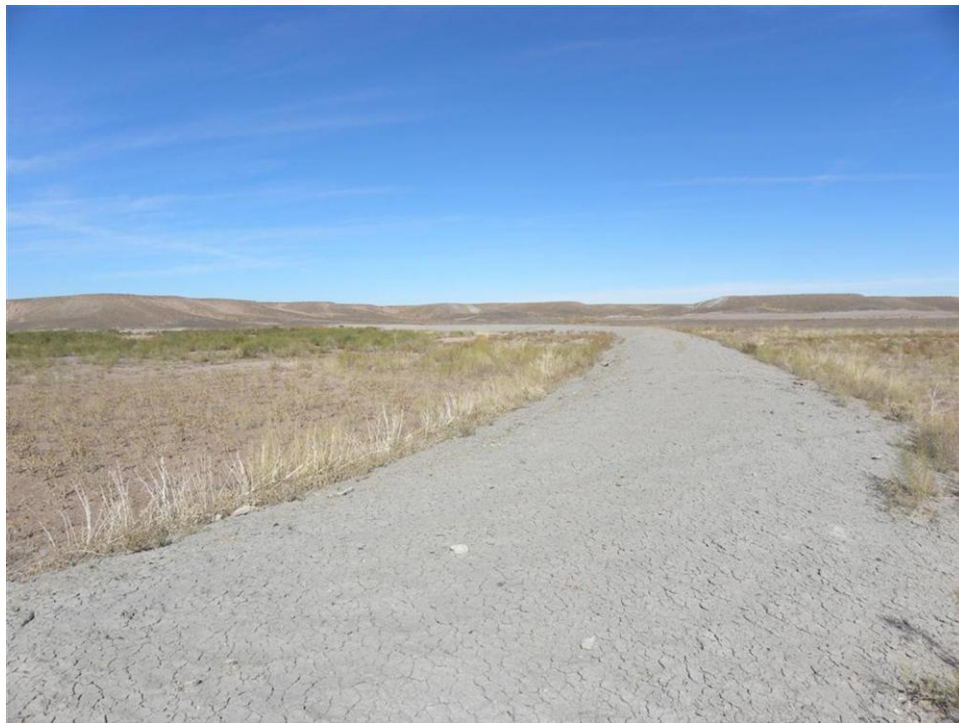
Section of berm surrounding former pond area from adjacent site (#153); erosion control berms in SW section

Photo 5. Ramco No. 22 mine site, berm along border with site #153
